**Flood Control Project Maintenance
Levee Inspections**

Maintenance Issue Types Only, Levee Inspection Report By Mile - Spring 2017

American River Flood Control District

Waterway	Bank	Unit Miles	Inspection Start/End	Inspector
Unit No. 01 Arcade Creek	Left	2.08	03/15/2017 05/03/2017	Maksim Khashchuk

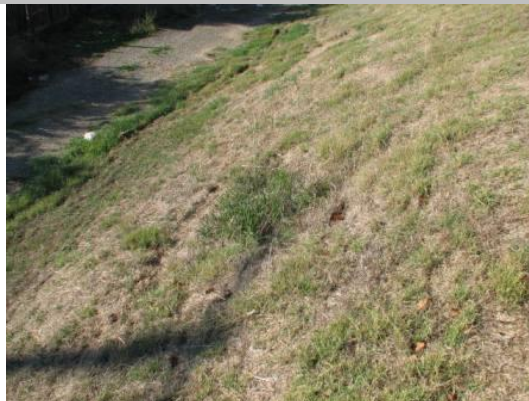
Photo 1 of 2 : SP_2017_NA0001_51_164_20170313_00052.jpg

LM Start	0.48	Rating **	A/W	Issue No.	164
LM End	0.48	Issue Type +	Ma	Location *	LS
Category	Earthen Levee			GPS Latitude/Longitude	
				Start	End
Item	Erosion / Bank Caving			38.623227 °	38.623227 °
				-121.460399 °	-121.460399 °
DWR ID	DWR_NA0001_01_s_2012_164				
Comment Code					
E1 : Note and monitor erosion site.					
Inspector Comment					
4'-5' diameter by 1' deep hole mid-slope on the landside.

11/17/2011 Hole/depression approximately mid-slope.

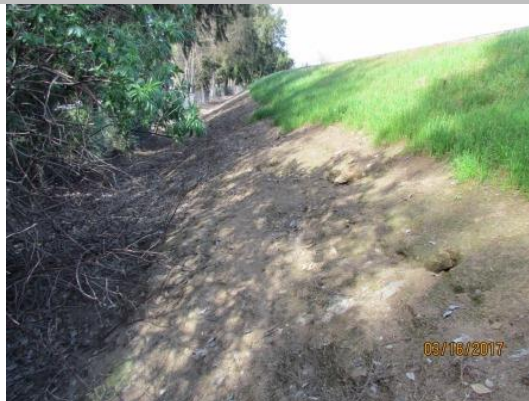
Photo 1 of 1 : SP_2017_NA0001_55_260_20170406_00262.jpg

LM Start	6.24	Rating **	U	Issue No.	260
LM End	6.24	Issue Type +	Ma	Location *	LS
Category	Earthen Levee			GPS Latitude/Longitude	
				Start	End
Item	Animal Control			38.566220 °	38.566220 °
				-121.423558 °	-121.423558 °
DWR ID	DWR_NA0001_04_s_2017_260				
Comment Code					
A1 : Exterminate rodents and backfill and compact or grout burrows.					
Inspector Comment

View of the rodent burrows at the levee toe.

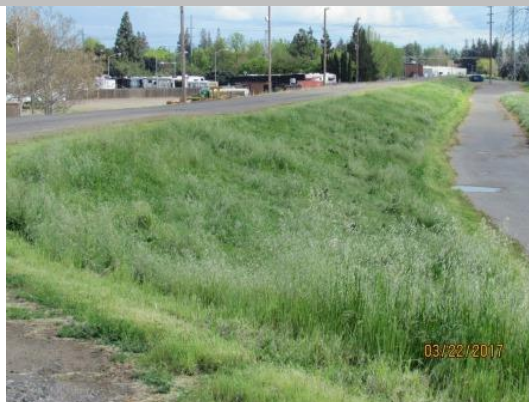
Photo 1 of 1 : SP_2017_NA0001_60_15_20170406_00044.jpg

LM Start	3.84	Rating **	M	Issue No.	15
LM End	4.18	Issue Type +	Ma	Location *	WS
Category	Earthen Levee			GPS Latitude/Longitude	
				Start	End
Item	Vegetation			38.585869 °	38.588924 °
				-121.423232 °	-121.428092 °
DWR ID	DWR_NA0001_09_s_2017_15				
Comment Code					
V1 : Control annual grass and weeds on the levee slopes and easements.					
Inspector Comment

View of the vegetation on the levee slope.
